# BERKELEY FIRE DEPARTMENT

## INCIDENT INVESTIGATION REPORT

Copy to	Report Date		X Information		_ Follow-up		Incident #	
	January 4, 2012		_ Continuation		_ Complaint		2011-010892	
	File	Adm	Ops	F.M.	BPD	Building	Other	Page No.
			x					1
Location, Building No., Apt/Room #, Street								
2441 Haste Street, Berkeley CA								
Document					Document Control			
Fire Investigation Report					<input checked="" type="checkbox"/> Confidential <input checked="" type="checkbox"/> Unrestricted Release

### NARRATIVE

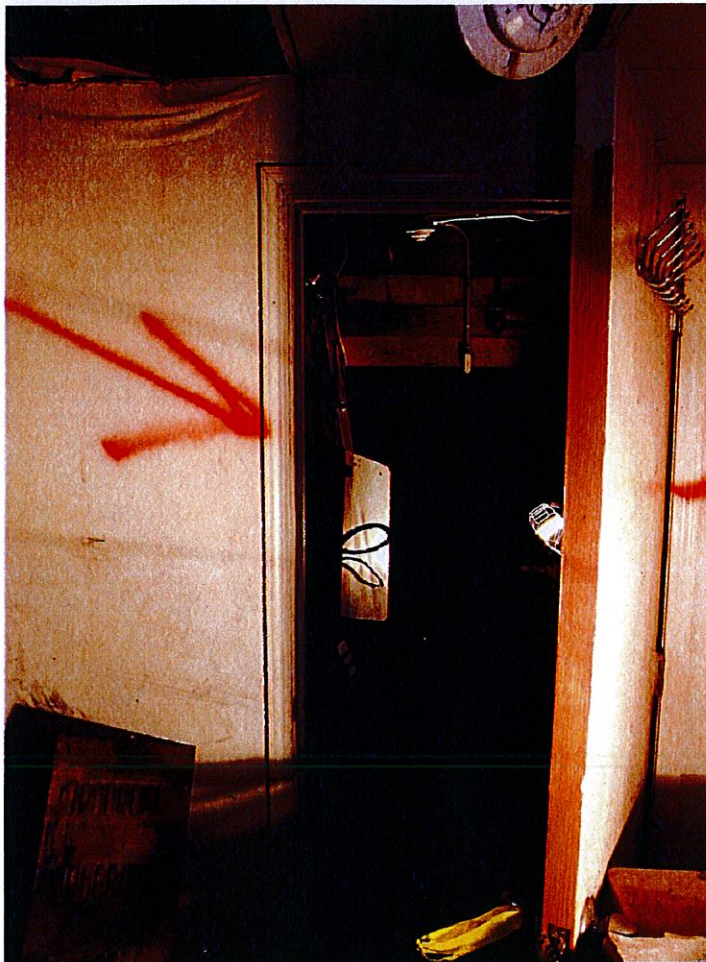
**Figure 2- Image 48 (file DSCF0402)** The elevator machine room door as seen from the ground floor center service corridor. This door is visible at the end of the corridor facing the camera in images 13/14 and 44/45. Smoke staining can clearly be seen above the door header and is consistent with smoke and heat venting from the machine room into the corridor. The fire in this space was the first attacked by the first responding engine company

- 47 DSCF0401.jpg Photograph of veneer brick used on the Haste and Telegraph faces of the structure. A measuring tape has been added for scale.
- 48 DSCF0402.jpg The elevator machine room door as seen from the ground floor center service corridor. This door is visible at the end of the corridor facing the camera in images 13/14 and 44/45. Smoke staining can clearly be seen above the door header and is consistent with smoke and heat venting from the machine room into the corridor. The fire in this space was the first attacked by the first responding engine company. The orange paint markings have been added by the insurance company's private fire investigators.[image by S.Riggs on 11/28/2011]

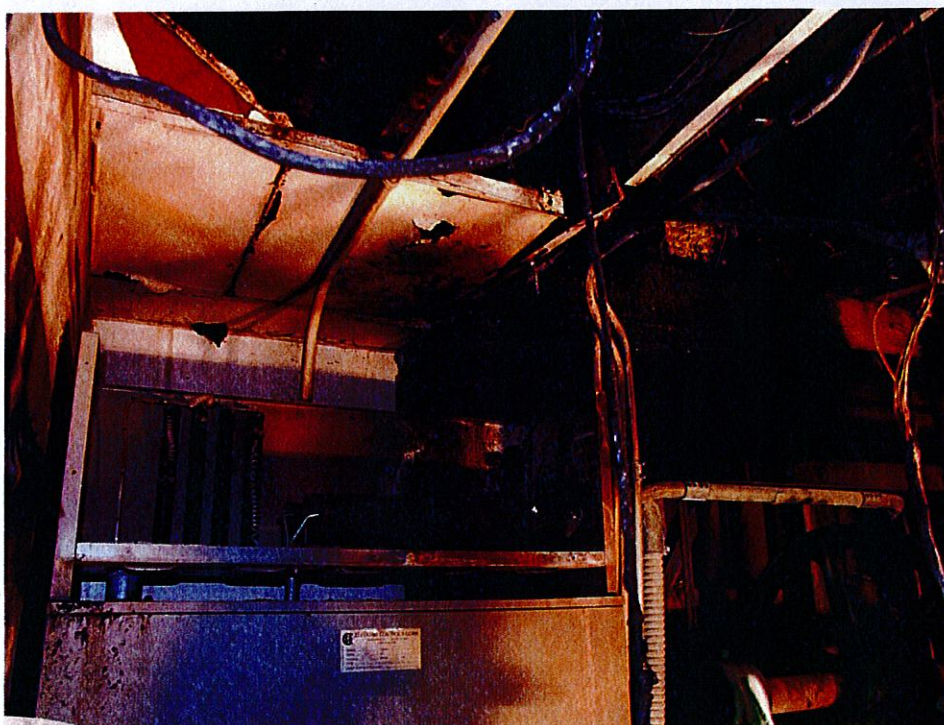
Inside the machine room doorway on the north wall at approximately 6' off of the floor I observed a distinct V burn-pattern extending up and outwards from the location of two elevator resistors associated with the elevator motor control equipment. A protective metal cabinet face had been removed by Fire Cause Analysis exposing the two resistors. Immediately to the left and right below the resistors, the fire, smoke and heat damage lessened significantly. Directly above the resistors I observed the V-burn pattern that continuously burned up and outward and extended through the opening in the ceiling up into the attic area above the room. It is my opinion the fire initially traveled from the elevator mechanical room up into the basement attic area to eventually to the other locations of the building. **(See appendix's #1 & #5, for detailed floor plan sketch/drawing and photographs).**

**Figure 3- Image 49** (file DSCF0403.jpg). The north wall of the elevator machine room showing the top of elevator control and power equipment and the elevator hoist equipment on the right. The wood at the hoistway header is burned in a vee pattern that suggests more intense heat and heat movement from the direction of the controller. The metal access panel which normally encloses the upper portion of the cabinet has been removed. The two cylindrical control resistors are visible mounted within the metal cabinet. A circular heat pattern is visible above the general location of the resistors. Multiple vee shaped heat patterns can be seen bracketing the location of the resistors in the right-rear corner of the metal cabinet. An additional heat pattern (evidenced by the rusting of the metal enclosure) is visible directly below the resistors.

- 49 DSCF0403.jpg The north wall of the elevator machine room. An elevator motor pulley and the elevator hoist cable can be seen on the right side of the image. The elevator control and power equipment are on the left side of the image. The wood at the hoistway header is burned in a vee pattern that suggests more intense heat and heat movement from the direction of the controller. The metal access panel which normally encloses the upper portion of the cabinet has been removed by the private investigators. The two cylindrical control resistors are visible mounted within the metal cabinet. A circular heat pattern is visible above the general location of the resistors. Multiple vee shaped heat patterns can be seen bracketing the location of the resistors in the right-rear corner of the metal cabinet. An additional heat pattern (evidenced by the rusting of the metal enclosure) is visible directly below the resistors. [image by S.Riggs on 11/28/2011]

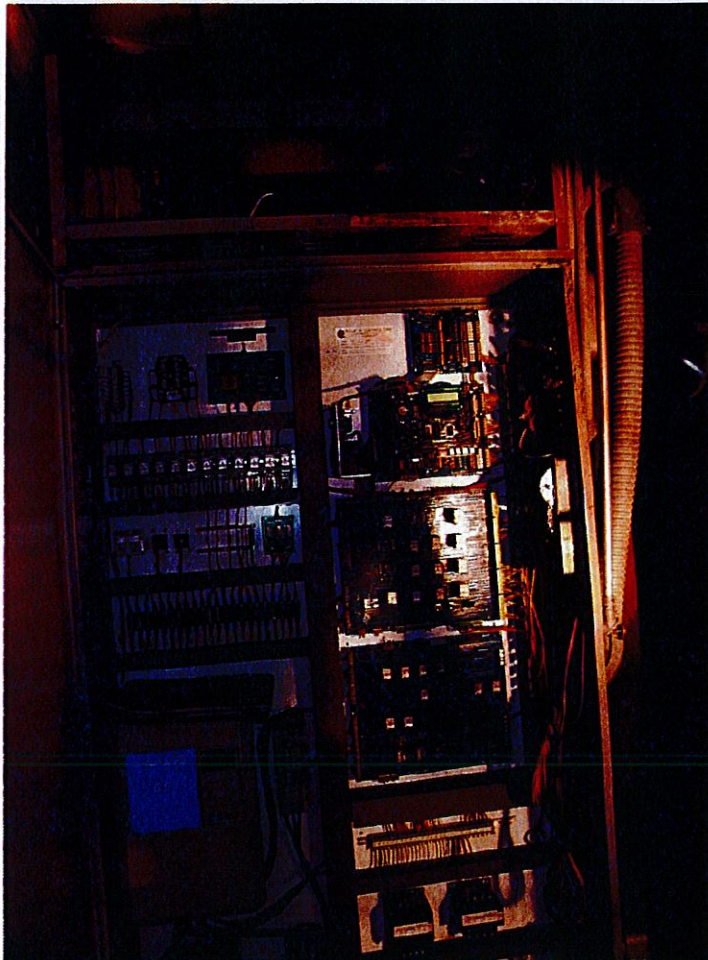
**Figure 4-** Image 65 (file DSCF0419.jpg) The elevator controller with the main access panel removed. There is no indication of heat or fire damage within the main equipment enclosure.

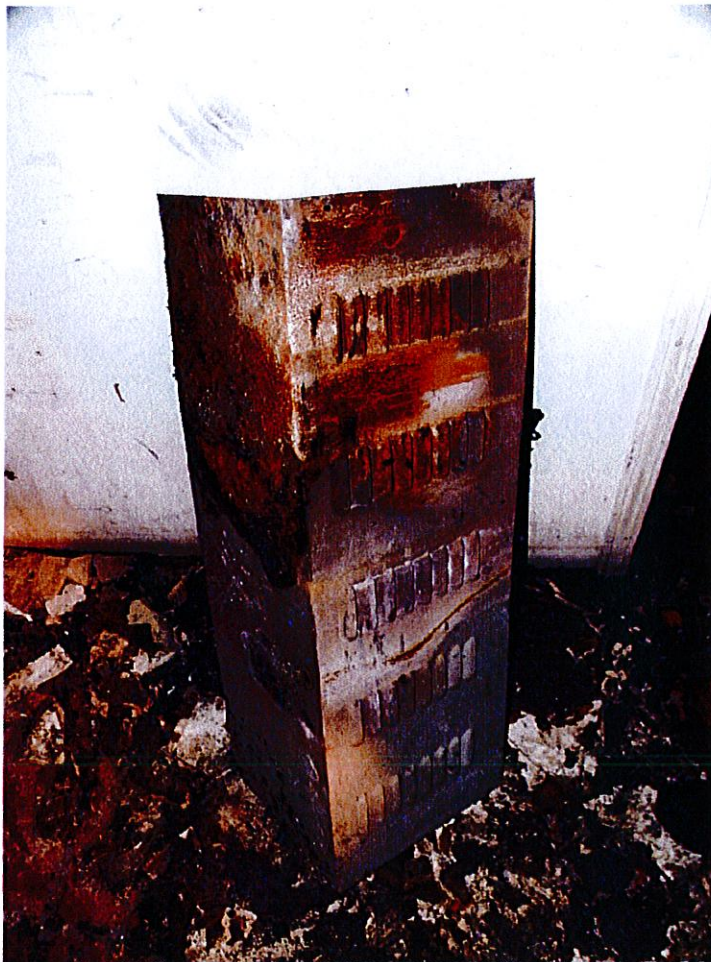
I examined the metal cover plate that had been removed from the resistors and observed the heat/burn patterns were much more intense on the inside face of the cover compared to the outside. Eventually the entire metal cabinet where the elevator resistors were located was removed and I observed a very distinct heavy burn-v pattern on the wooden wall directly behind where the resister metal compartment had been located. Based on my observations, it is my opinion this fire originated in and around the steel compartment where the elevator resistors were located. **(See appendix's #1 & #5, for detailed floor plan sketch/drawing and photographs).**

**Figure 5- Image55** (file DSCF0409.jpg). An angled view of the controller cover. The front (louvered side) and top of the panel are clearly visible. The rusting visible on the panel is typical of ferrous metals heated to extreme temperatures and then exposed to water or high humidity (such as firefighting water or humid post-fire conditions). The patterns appear centered over the approximate location of the resistors

- 55 DSCF0409.jpg An angled view of the controller cover. The front (louvered side) and top of the panel are clearly visible. The rusting visible on the panel is typical of ferrous metals heated to extreme temperatures and then exposed to water or high humidity (such as firefighting water or humid post-fire conditions). The patterns appear centered over the approximate location of the resistors. [image by S.Riggs on 11/28/2011]

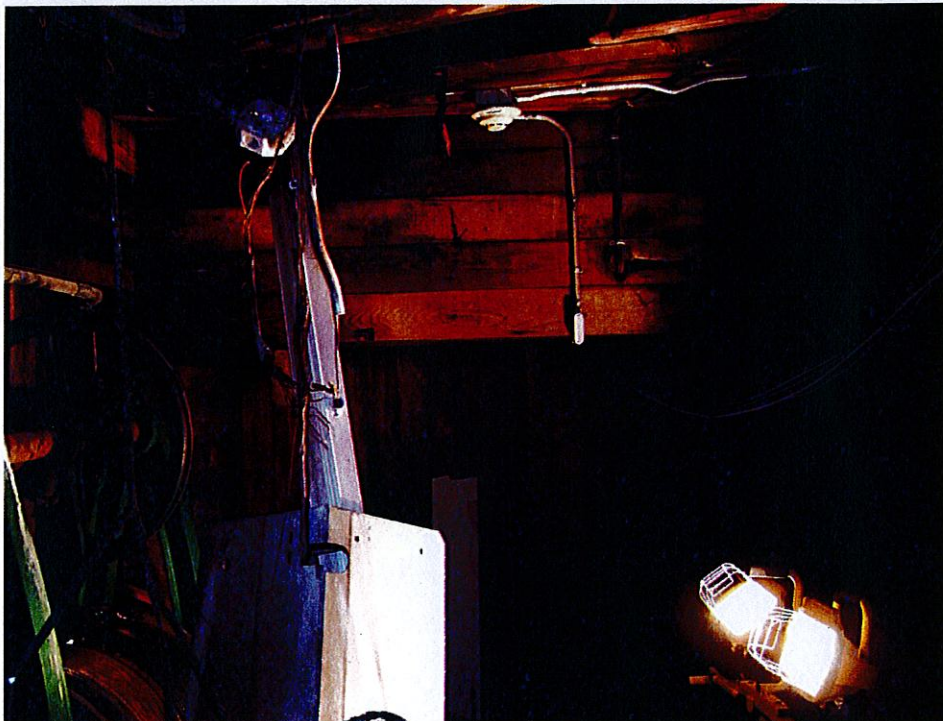
The undersides of much of the remaining wood ceiling planks (the side exposed to the machine room) were either undamaged or lightly damaged by smoke and heat. The upper surfaces showed heavy alligating and mass loss. The upper edges of the planking were well rounded. (See appendix's #1 & #5, for detailed floor plan sketch/drawing and photographs).

**Figure 6-** Image 52 (file DSCF0406.jpg). The ceiling of the elevator machine room looking towards the east wall. The fire alarm heat detector can be seen mounted on the ceiling. Much of the ceiling is intact and unburned. Ceiling areas that are burned through on the left show much more significant damage to the top surfaces of the ceiling boards, suggesting that fire development was greater and/or earlier in the space above the ceiling.

- 52 DSCF0406.jpg The ceiling of the elevator machine room looking towards the east wall. The fire alarm heat detector can be seen mounted on the ceiling. Much of the ceiling is intact and unburned. Ceiling areas that are burned through on the left show much more significant damage to the top surfaces of the ceiling boards, suggesting that fire development was greater and/or earlier in the space above the ceiling. [image by S.Riggs on 11/28/2011]
